Evaluating a groundwater supply contamination incident attributed to Marcellus Shale gas development

Here we provide data for a contamination incident from PA where the regulator (PA Department of Environmental Protection, PADEP) concluded that stray natural gas derived from nearby Marcellus Shale gas wells contaminated the aquifer used by at least three households in southeastern Bradford County, PA (Fig. 1). In addition to gas, the well waters were also observed to foam (Fig. 1C), but no cause was determined. To investigate this and other contaminants present, we demonstrate an investigative approach to identify unique organic unresolved complex mixtures (UCMs) and a target compound linked to shale gas-related contamination (2-n-Butoxyethanol, 2-BE).

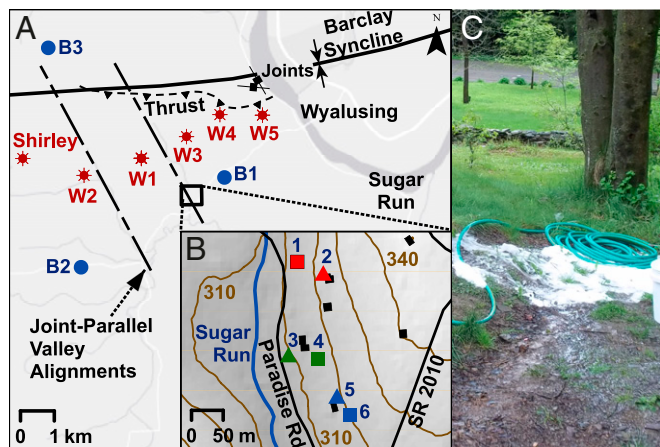
Fig. 1. (A) Study area showing the communities of Wyalusing and Sugar Run located on Susquehanna river (dark grey), gas wells (Shirley, Welles 1–5 well pads labeled as W1 through W5), domestic water wells not impacted by gas drilling activities (B1–B3), and notable geologic features (thrust fault surface expression, regional joint orientation, axis of syncline). (B) Expanded view of tributary of Sugar Run creek (blue line) showing domestic water Wells 1–6 impacted by gas drilling activities. Wells 2, 3, and 5 (triangles) are original impacted wells. Wells 1, 4, and 6 (squares) are replacement wells provided by gas company that also showed contamination. Brown lines are elevation contours (m-msl). Black squares are structures and lines are roads. (C) Foam emitted during purging of domestic water Well 2 in Spring, 2012.

Hydrogeologic Considerations. The impacted homeowner wells lie along the north branch of Sugar Run valley between the axes of two east–west aligned structural folds (Fig. 1 and Fig. S9). The concave Barclay fold (syncline), is located 1–3 km to the north of Welles 1–5 pads; the convex Wilmot fold (anticline) lies to the south at a distance of 5–7 km (Fig. S9). Under the impacted valley (between the folds), bedrock strata dip ~ 5 –10 degrees downward to the northwest toward the Welles series gas wells.

Even though drinking water consistently foamed in three households in Bradford County (e.g., Fig. 1C), commercial laboratories reported no compounds other than natural gas present at concentrations above regulatory recommended action levels, and no constituents were detected above regulatory drinking water standards. However, commercial laboratory analyses did sporadically detect ethylene and propylene glycol and surfactants near microgram-per-liter detection limits (*SI Text*). When we analyzed a subset of the household waters with GCxGC-TOFMS in 2012, we detected very low concentrations of 2-BE. This compound is of special interest because the US Environmental Protection Agency (USEPA) has suggested that 2-BE could be an indicator of contamination from HVHF activities (29). Additional information on 2-BE is provided in *SI Text*. GCxGC-TOFMS also documented a UCM of organic contaminants in all three water wells analyzed. Background groundwater outside of the affected area had no such contamination (Fig. 4B and Fig. S8). It is not possible to prove unambiguously that the UCM and 2-BE were derived from shale gas-related activities. However, the timing (Fig. 2 and Table S1) and the presence of UCMs and 2-BE in flowback/production waters in PA (Fig. 3) are consistent with shale gas activity as the most probable source.

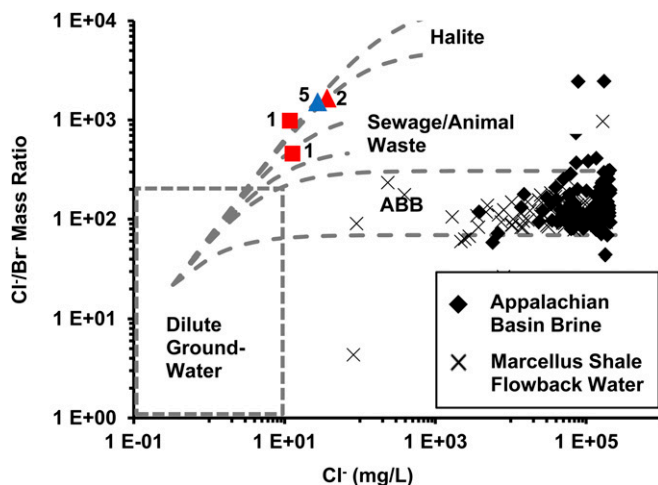
Fig. 6. Crossplot of Cl/Br mass ratio vs. Cl concentrations for samples collected from Wells 1, 2, and 5 (labeled) with bounding upper and lower conservative mixing curves for various endmembers (e.g., Appalachian Basin brine, sewage and animal waste, and halite sources). Appalachian Basin brine samples (20–22, 24) and Marcellus Shale flowback samples (23, 25, 26) are also plotted for comparison.

Inorganic Analysis. Conservative inorganic constituents (e.g., Cl and Br) can be used to determine if flowback or production waters have contaminated groundwater because these wastewaters can contain total dissolved solids in concentrations greater than 300,000 mg/L (6, 18). Further, if upward migration of HVHF fluids occurred after mixing with formation waters, dissolved Cl/Br mass ratios are more likely to be useful as effective fingerprints than the HVHF fluid components themselves, due to their more conservative behavior in groundwater (6, 10). Crossplots of Cl/Br (mass ratio) versus Cl concentration (Fig. 6) can help elucidate the source of Cl. For example, the natural water quality data for Salt Spring in Susquehanna County, PA, documents that Appalachian Basin brine (ABB) up-wells naturally into groundwater and surface water in Susquehanna County in that location as well as others (18). Although diluted, this spring water has a similar composition to flowback/production waters throughout PA and a few other brine springs and deep formation waters in the state (18–26) (Fig. 6 and Table S6). Conversely, Fig. 6 illustrates that the Cl concentrations and Cl:Br ratios of the impacted household waters from Bradford County are more likely gaining dissolved salts from sources with higher Cl:Br mass ratios than ABB.
